# BENCHMARK PROJECT MANAGEMENT (UK) LTD CASE STUDY

Buckley Barracks Basketball Court Refurbishment

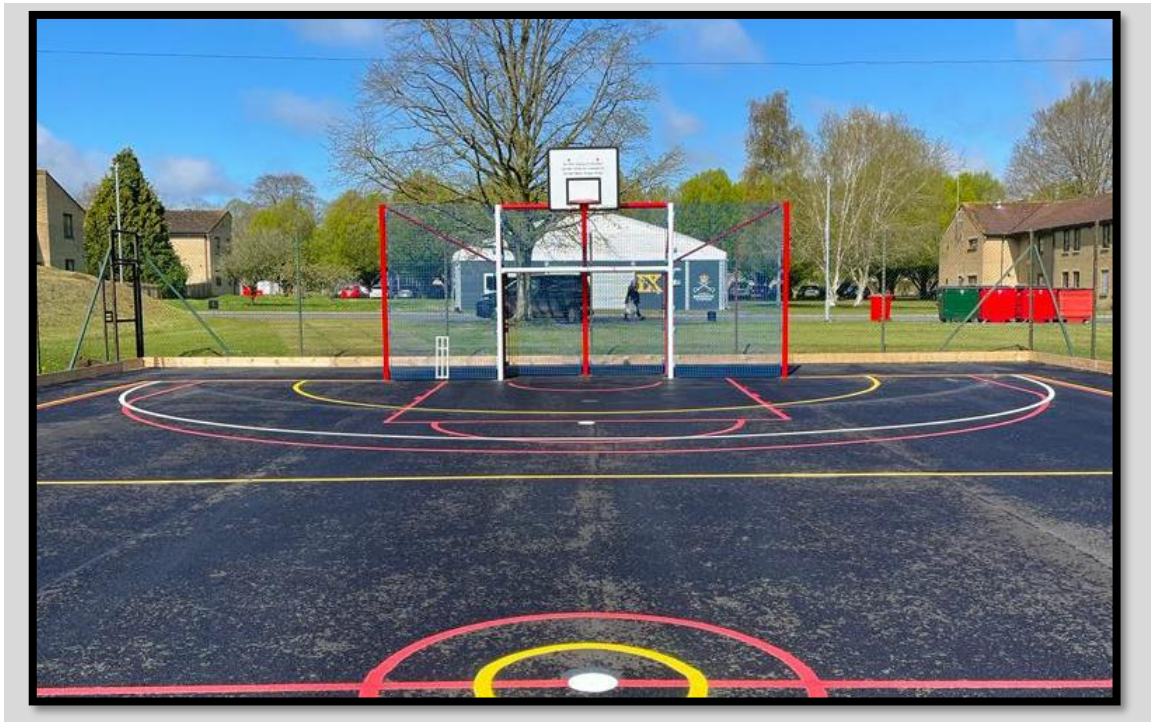
Buckley barracks basketball court which is sited between buildings 45 and 355 was previously in poor condition. The surface had loose chippings, the fence was unstable and curling up and the posts were showing signs of decay. The perimeter edging had become loose in sections and some brickwork was missing. The camp requested that the court to be completely refurbished restoring the court to a usable standard.

- Retaining brick repairs
- Puncture surface course with equally spaced 50mm dia holes and fill with single sized clean 6mm stone to aid drainage.
- Swept clean court surface and spray K140 tack coat.
- Lay & roll 25mm depth of 6mm permeable sports play surface course.
- Install 2no. fixed, combined football goals and basketball backboards.
- Line mark surface for Netball, basketball, and 5-a-side football in line with sports England guidance.
- Replace all chain link tensioning lines.
- Install 200mm high x 50mm wide timber kick board around the perimeter of the court.

- To improve drainage of new asphalt court and improve longevity, the court was punctured with equally spaced 50mm dia holes and filled with clean 6mm stone. Using a 110v drilling rig, we diamond core drilled 655no. holes at 1.0m centres.
